FACT SHEET

Reservoir Summaries

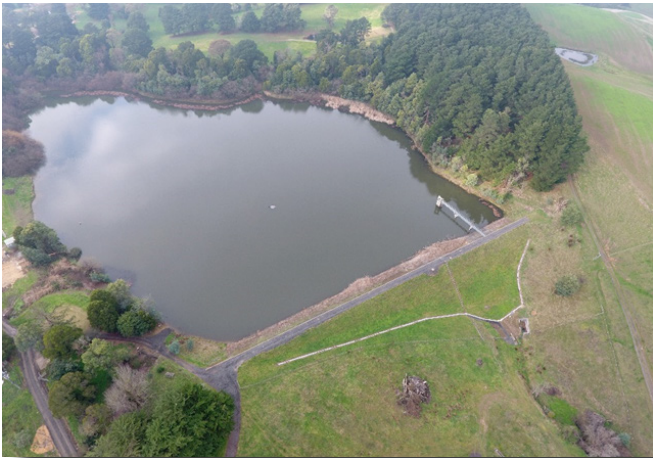
Coalition Creek Dam

- Erosion through the embankment
- Poor condition of crest, upstream concrete wall and spillway
- Low stability of embankment
- Stability of the outlet tower and embankment is under earthquake loading

- Downstream filter buttress, embankment raise, upgrade spillway and outlet tower anchorage
- \$6.0M (2015 costs)

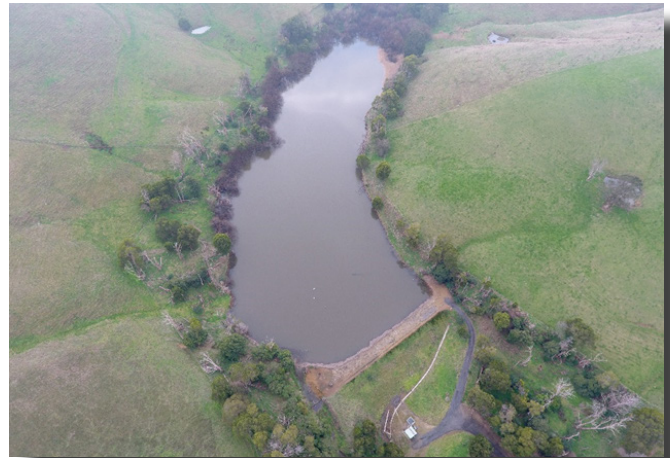
Ness Gully Dam

- Erosion through the embankment
- Poor condition of crest and downstream embankment
- Spillway capacity insufficient

- Downstream filter buttress, spillway upgrade, embankment improvement. \$4.8M (2015 costs)

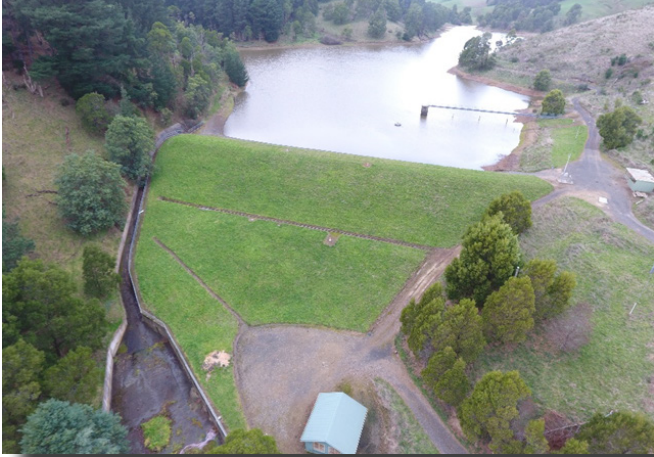
Bell View Creek Dam

- Erosion through the embankment
- Stability of the outlet tower and embankment under earthquake loading
- Spillway remedial works required

- Downstream filter buttress, spillway strengthening and tower anchorage; \$4.7M (2015 costs)

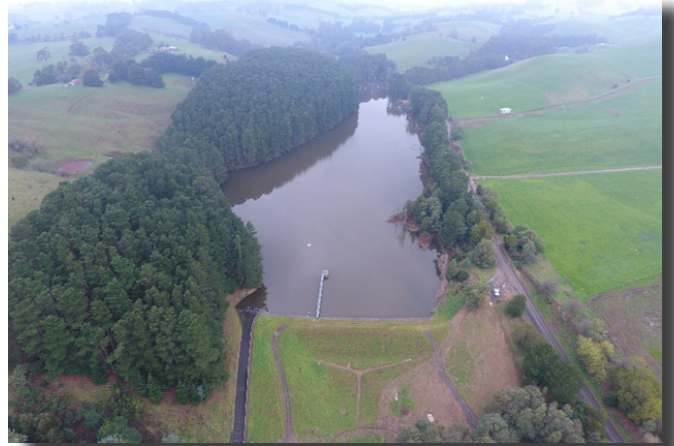
Little Bass Dam

- Erosion through the embankment and saturated foundation conditions
- Stability of the outlet tower under earthquake loading

- Downstream filter buttress, strengthen outlet tower, replace walkway piers, embankment improvement works; \$3.3M (2015 costs)
