### 4km of Hi-Tech Sewer Relining for Leongatha

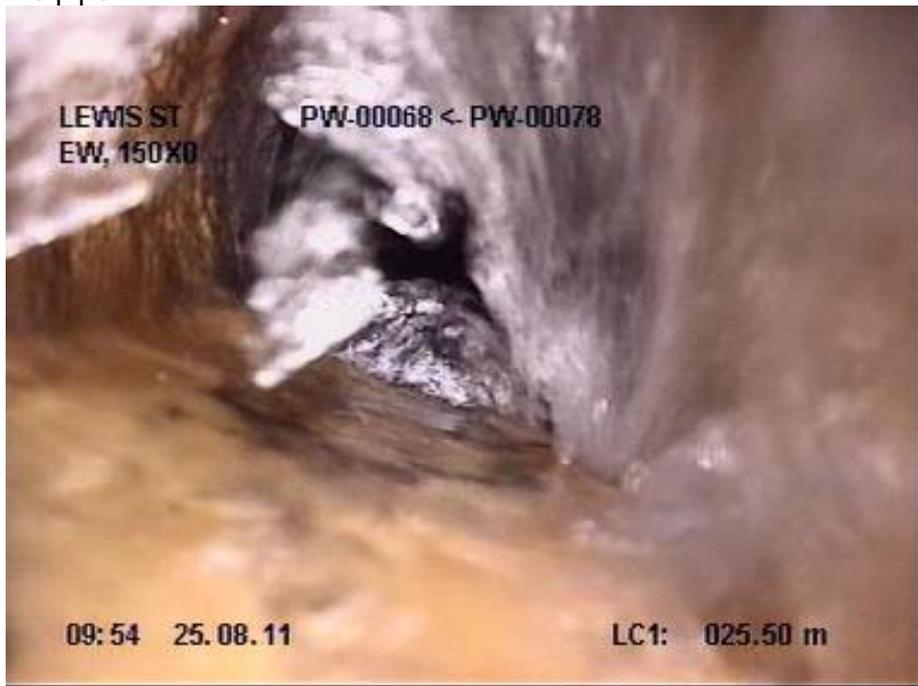
[Image] Before: Approximately 35 litres per minute of groundwater entering the sewer through a break in the pipe

Once cleaned, the next stage is to prepare the liner for installation. The liner is then heated using steam, making it pliable. Once the liner is hot and flexible it is inserted into the existing sewer pipe.

Once installed it is pressurised with hot steam, pushing it out against the wall of the existing pipe. This pressure is maintained for approximately 30 minutes. After this time pressure is reduced slowly, allowing the PVC liner to cool. Once cooled the plastic returns to a rigid pipe and fully seals the sewer. During this curing stage some residents may notice a plastic or epoxy smell, however this quickly dissipates.

A small robotic cutter is sent into to cut out any junctions where homes and businesses connect to the sewer pipeline. As a continuous piece of PVC liner is used in the process, there are no joins which may break in future, meaning that the expected lifespan of the repaired sewer is extended.

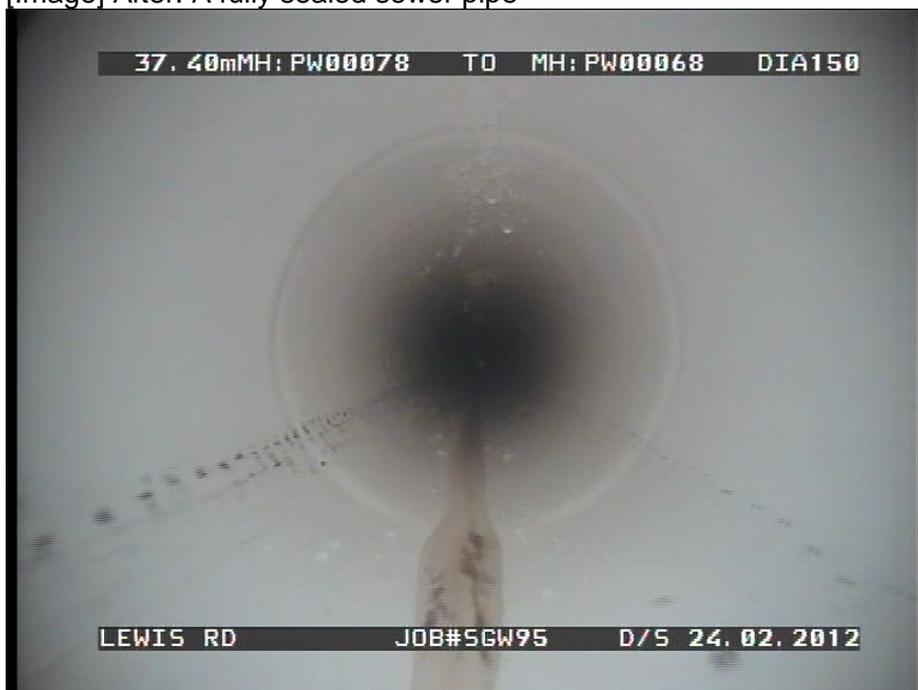
[Image] After: A fully sealed sewer pipe
