Annual Drinking Water Quality Report 2022-23

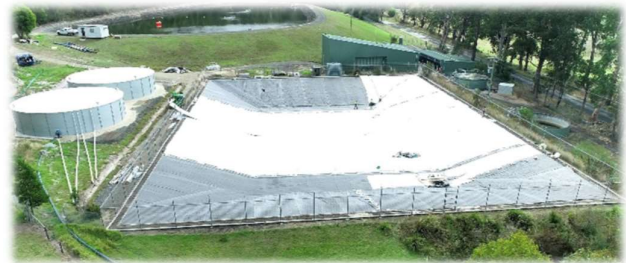
Photo: CWS Renewal works at Devon North WTP

Additional highlights include the completion of major renewal projects at both the Devon North and Poowong clear water storage basins. The projects involved the complete replacement of geomembrane linings and coverings of the basins to ensure continued protection of drinking water long into the future. Extensive planning and preparations were

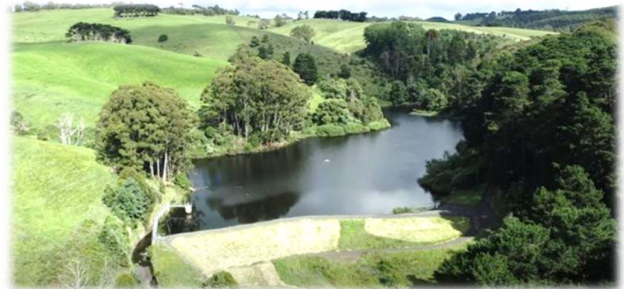
Photo: Ruby Creek reservoir system

In the morning of Saturday, the 27th of August 2022, an incident occurred involving a significant break in the transfer main supplying raw source water from the Ruby Creek reservoir system to the Leongatha water treatment plant. The break caused a complete disruption of raw water supply to the treatment plant, and, consequently, the cessation of potable drinking water production. As a result, drinking water supply to Leongatha and Koonwarra became entirely dependent on existing volumes in clear water storage tanks.

A root cause analysis found that age-related weakening of the transfer main construction material contributed to the break. This rendered the main susceptible to external pressures resulting from land movement. Evidence of a land slip above the main in the area of the break was observed as was soil erosion into Ruby Creek, in the region downhill of the main.

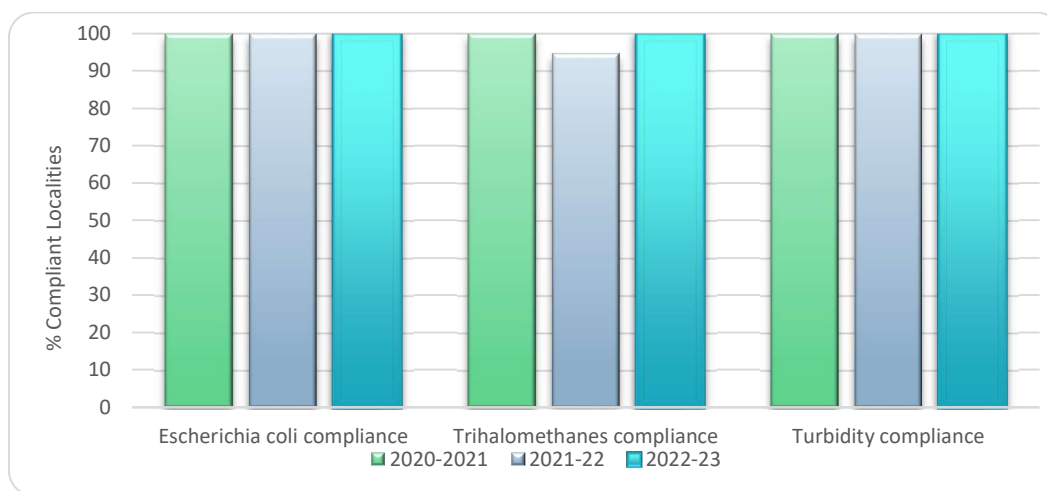
Figure 2: Percentage of localities where the drinking water complied with the water quality standards for *Escherichia coli*, trihalomethanes, and turbidity

A comparison of compliance with water quality standards specified in Schedule 2 of the Safe Drinking Water Regulations 2015 in the 2022-23 period with that of the previous two fiscal years is presented in Figure 2. Consistent compliance across all South

Gippsland Water water sampling localities is illustrated and in measure with the water quality standards listed for *Escherichia coli* and turbidity. A single exceedance of the drinking water quality standard for trihalomethanes in Fish Creek reduced the percentage of compliant localities to 94.7 for the 2021-22 period. Refer to the [2021-22 Annual Drinking Water Quality Report](#) for details.
