Essential Sewer Re-lining for Foster, Korumburra & Leongatha Pipes

After Closed Circuit TV (CCTV) inspections of sewer mains in Foster, Leongatha and Korumburra, a number of pipelines have been identified as needing rehabilitation and repair.

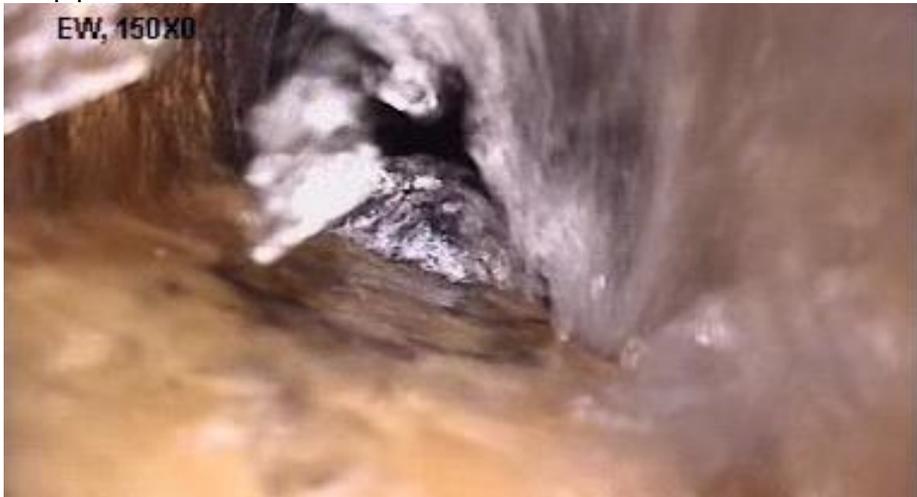
[Image] Before: Approximately 35 litres per minute of groundwater entering the sewer through a break in the pipe

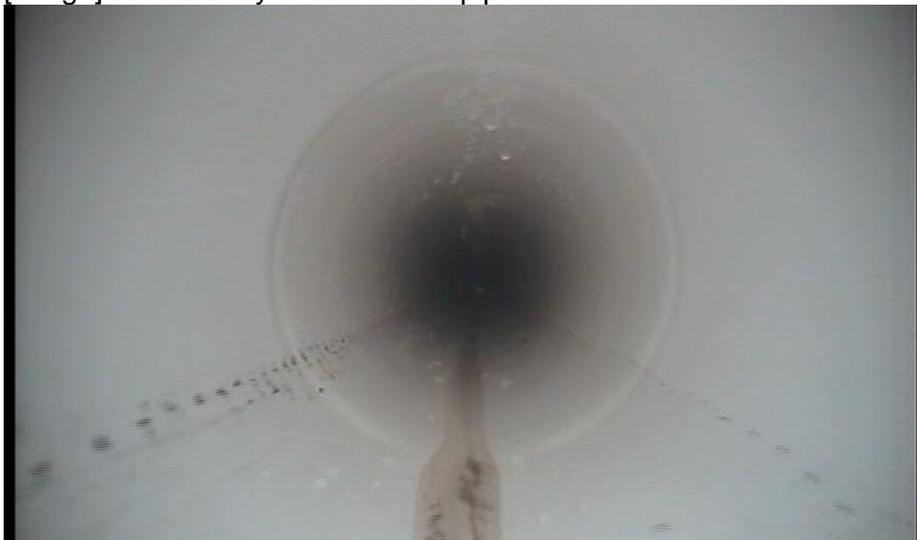
[Image] After: A fully sealed sewer pipe

The sewer pipe in question is cleaned (jetted with high pressure water) and inspected with a CCTV camera which determines the condition and extent of infiltration. A long continuous PVC pipe liner is made to length.

The next stage is to prepare the liner for installation by heating it using steam, to make it pliable. Once the liner is hot and flexible it is inserted into the existing sewer pipe.

Following installation, it is pressurised with hot steam, expanding it against the wall of the existing pipe. This pressure is maintained for approximately 30 minutes. Pressure is reduced slowly, allowing the PVC liner to cool. When cooled, the plastic returns to a ridged pipe and fully seals the sewer.
