Essential Sewer Re-lining for Korumburra & Leongatha Pipes

After Closed Circuit TV (CCTV) inspections of sewer mains in Leongatha and Korumburra during 2019, a number of pipelines have been identified as needing rehabilitation and repair.

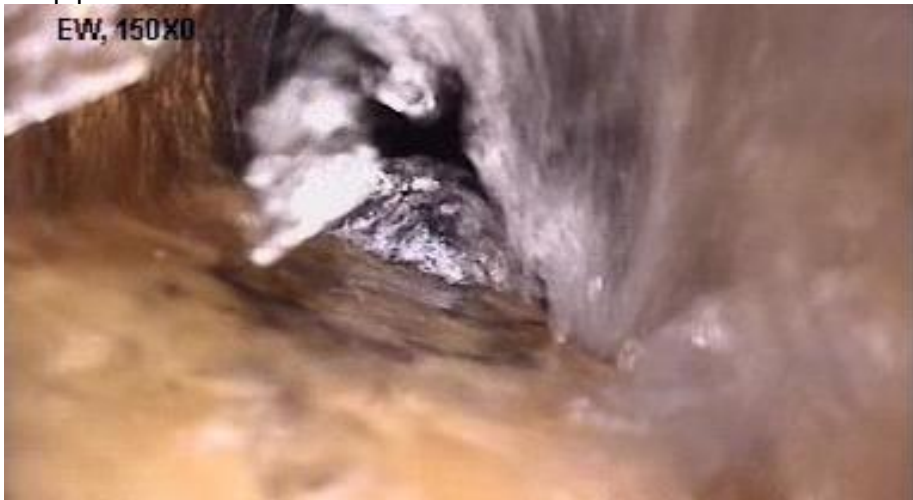
[Image] Before: Approximately 35 litres per minute of groundwater entering the sewer through a break in the pipe

The sewer pipe in question is cleaned (jetted with high pressure water) and inspected with a CCTV camera which determines the condition and extent of infiltration. A long continuous PVC pipe liner is made to length.

The next stage is to prepare the liner for installation by heating it using steam, to make it pliable. Once the liner is hot and flexible it is inserted into the existing sewer pipe.

Following installation, it is pressurised with hot steam, expanding it against the wall of the existing pipe. This pressure is maintained for approximately 30 minutes. Pressure is reduced slowly, allowing the PVC liner to cool. When cooled, the plastic returns to a ridged pipe and fully seals the sewer.

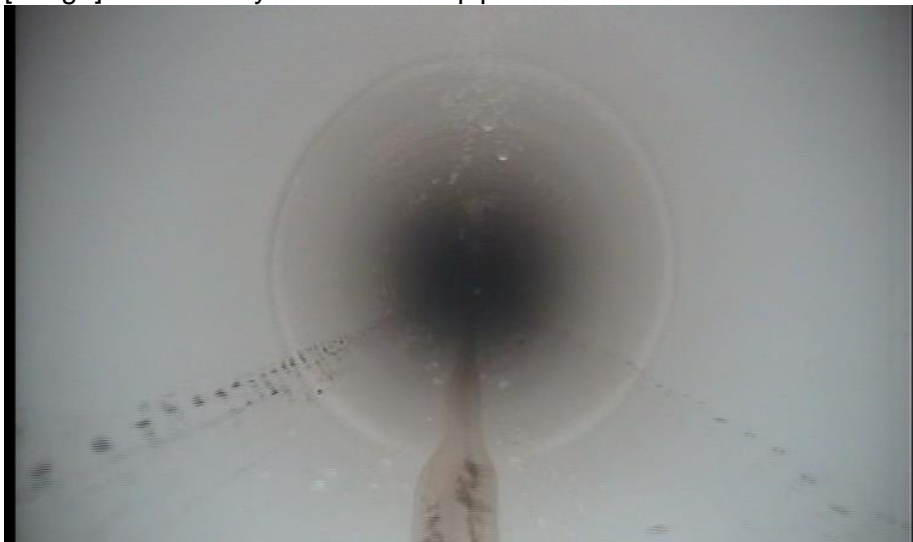
[Image] After: A fully sealed sewer pipe

As a continuous piece of PVC liner is used in the process, there are no joins which may break in the future, meaning that the expected lifespan of the repaired sewer is extended.
