ANNUAL DRINKING WATER QUALITY REPORT 2020-21

South Gippsland Region Water Corporation

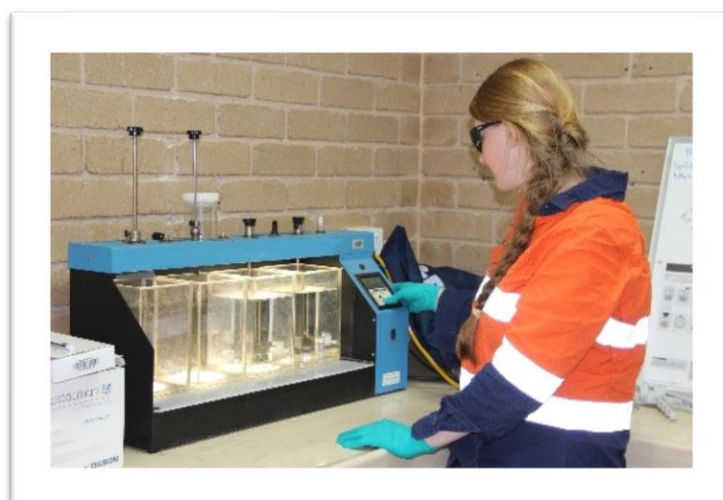
Photo: Water Treatment Plant Operator conducts a jar test

Continual process monitoring and jar tests are used in water treatment plant laboratories to simulate plant conditions and ensure correct dosage of treatment chemicals. This enables optimisation of treatment processes in response to changes in raw water quality and other factors. Occasionally issues arise out of the application of water treatment processes and corrective actions must be taken.

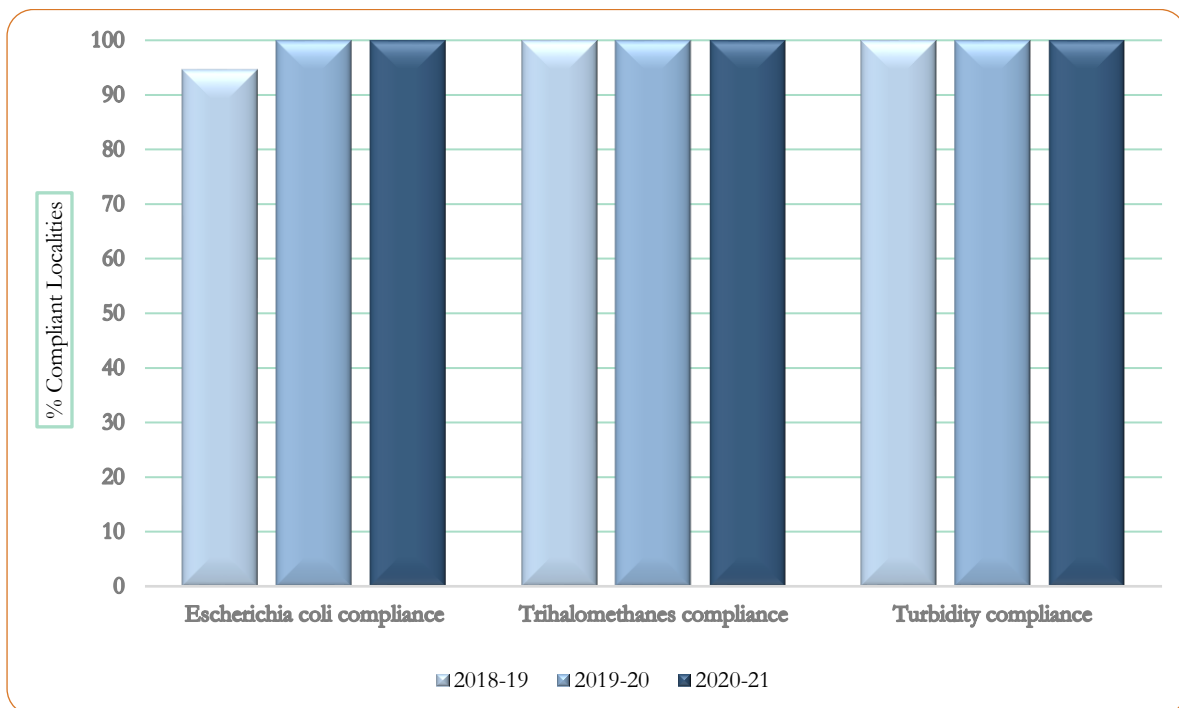
Figure 2: Percentage of localities where the drinking water complied with the water quality standards for *Escherichia coli*, trihalomethanes and turbidity

A comparison of compliance with water quality standards specified in Schedule 2 of the Safe Drinking Water Regulations 2015 in the 2020-21 period with that of the previous two fiscal years is presented in Figure 2. Consistent compliance across all South Gippsland Water water sampling localities is illustrated and in measure with the water quality standards listed in Schedule 2 of the Regulations for *Escherichia coli*, Trihalomethanes and Turbidity.
